AEROSPACE REPORT NO.  
TR-93(3478)-1

## Investigation of ACC/CCI Tunnel Diodes

1 November 1993

THE AEROSPACE  
CORPORATION  
El Segundo, California

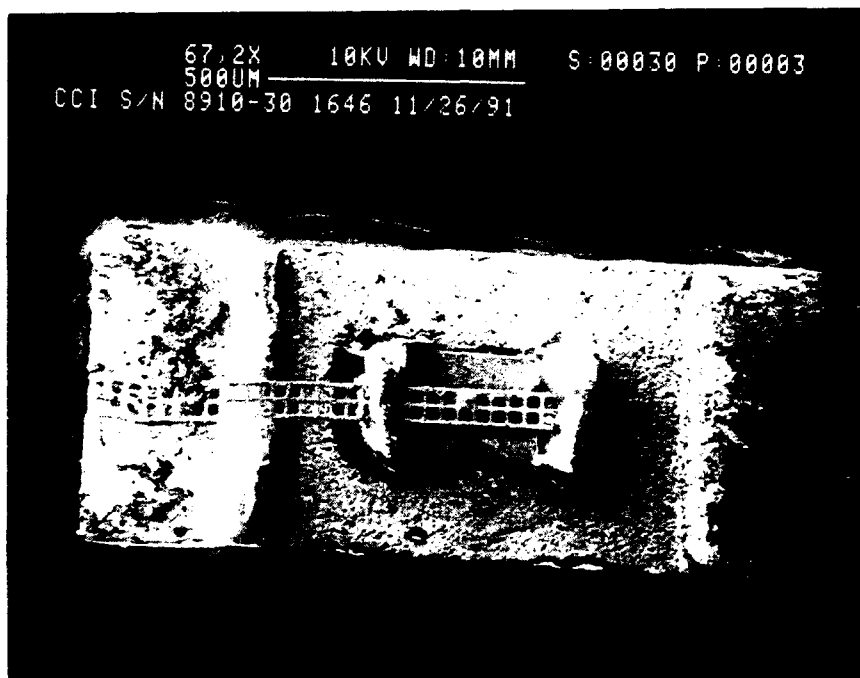
Figure 4. Electron micrograph showing the complete diode assembly (DSMP device, LDC 8910, S/N 30, 67 $\times$  magnification).

The DMSP failed device, LDC 8910, serial number 30, was subsequently brought to Aerospace. In ACC/CCI internal company nomenclature, this device is termed "type MM2." This device had been installed in a detector module. Hi-Rel Laboratories had deprocessed the module and removed the diode assembly. During a trip to ACC/CCI, two other MM2 diodes, still installed in detector modules, were obtained. In addition, ten diode assemblies of type "MM6" were also received for evaluation. Not all of these devices were examined, however. The investigation at Aerospace was undertaken in order to take a further look at the tunnel diodes complementary and supplementary to the Aerojet/Hi-Rel analysis. Most of the results reported in this section were obtained on device LDC 8910, S/N 30.

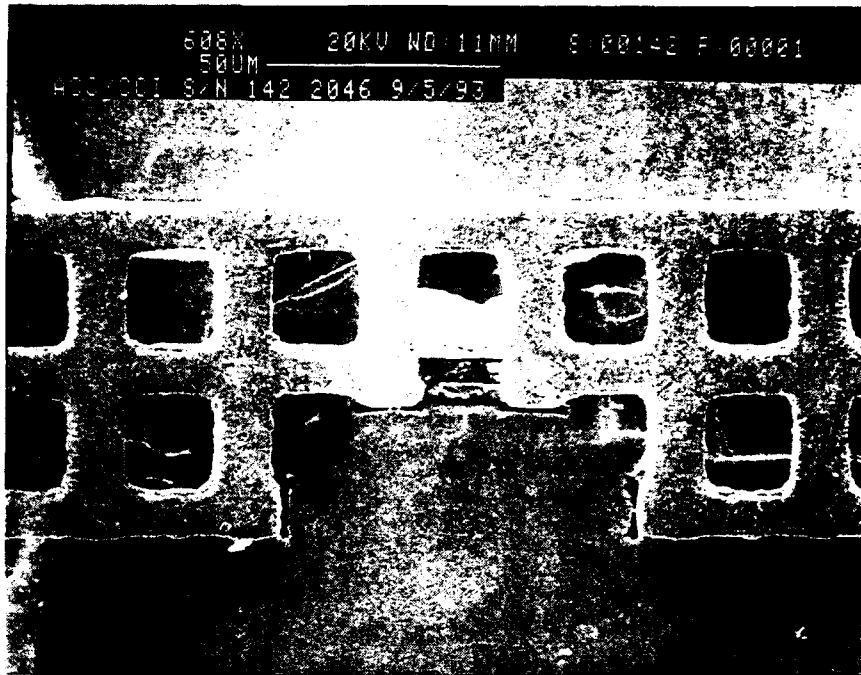
Diode S/N 142 is a particularly interesting case. The mesa of this diode, as received, was covered by epoxy. There was no sign of the graceful, tapering "stalk" that we have come to expect in tunnel diodes (Figures 19a,b). The device was etched in an oxygen plasma, and the epoxy removed — still with no obvious mesa. The Ge appears to have fractured. The ribbon appeared to have been "mashed down" along one edge, and it seemed that the view of the mesa might simply have been blocked by the ribbon. Using the FIB, the ribbon was cut away to better expose the mesa region (Figures 20a,b); still, no "stalk" could be seen. The other side of the ribbon was also cut away, and, again, a tapering stalk was not evident (Figures 21a,b).

Figure 20a. One side of the ribbon has been cut away by ion milling to better expose the ball-mesa contact (NASA device, S/N 142, 608 $\times$  magnification).

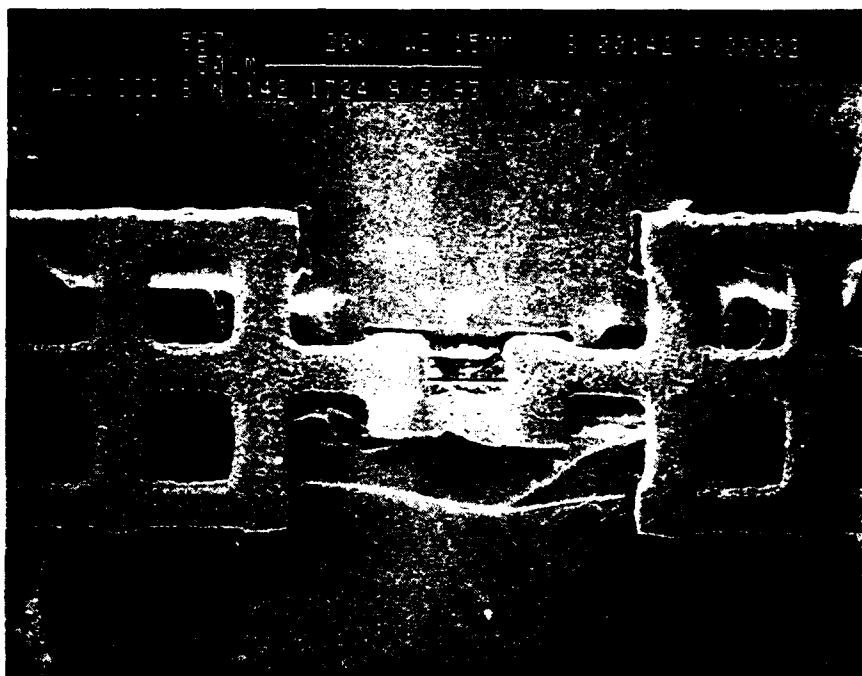
Figure 21a. The other side of the ribbon has been cut away to further expose the contact region (NASA device, S/N 142, 567 $\times$  magnification).
